# **Summary Report: Waituna Peak Runoff Control Structure Trial**

**Land and Water Science Report 2023/02  
January 2023**

## Waituna Peak Runoff Control Structure Trial

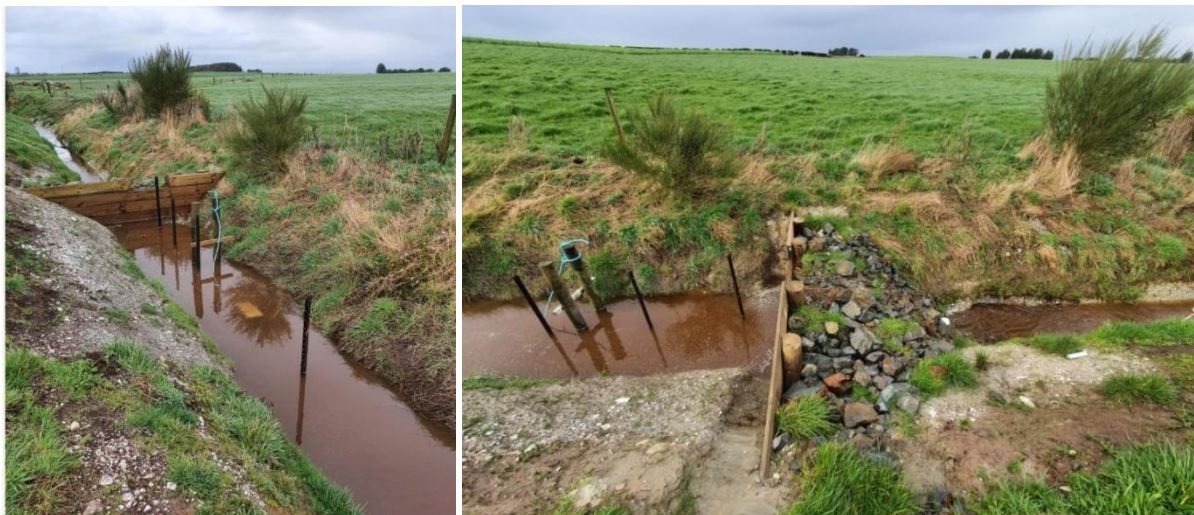
Figure 9: Site 4 Wooden weir looking downstream (left) and showing rock backfill downstream (right).

Figure 8 below shows an indicative engineering diagram of the post and timber weir structures constructed at Sites 4 and 5. Figures 9 and 10 show the construction and general layout of the timber PRC structures installed at each site.

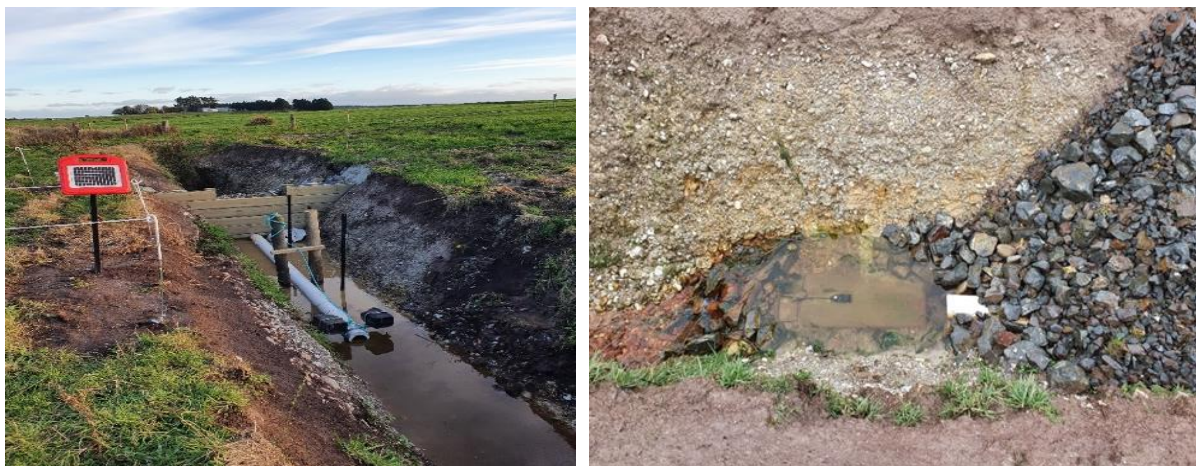
Figure 10: Site 5 wooden weir following installation looking downstream (left) and flow monitoring equipment installed downstream of culvert pipe (right).

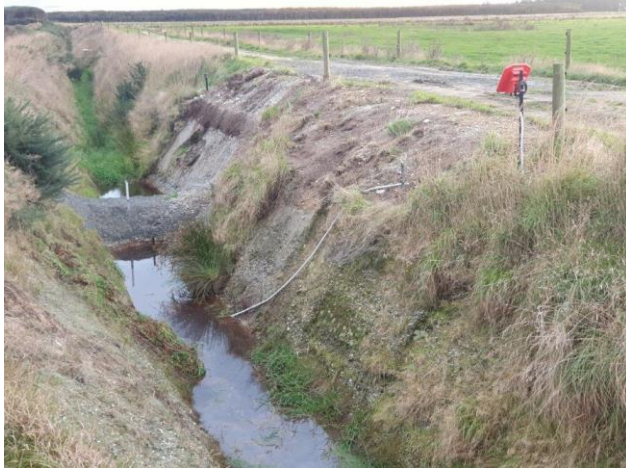
*Figure 11: Site 1 Gravel weir initial installation looking upstream, May 2021.*

The initial gravel weir constructed at Site 1 is shown in Figure 11. As illustrated in Figure 12, progressive erosion of the gravel materials during high flows was observed, with the weir ultimately failing due to scour of the weir crest during a high flow event in late July 2021. Following the July 2021 failure, Site 1 was reinstated using rock ballast as shown in Figure 13 remaining operational for the remainder of the trial period.

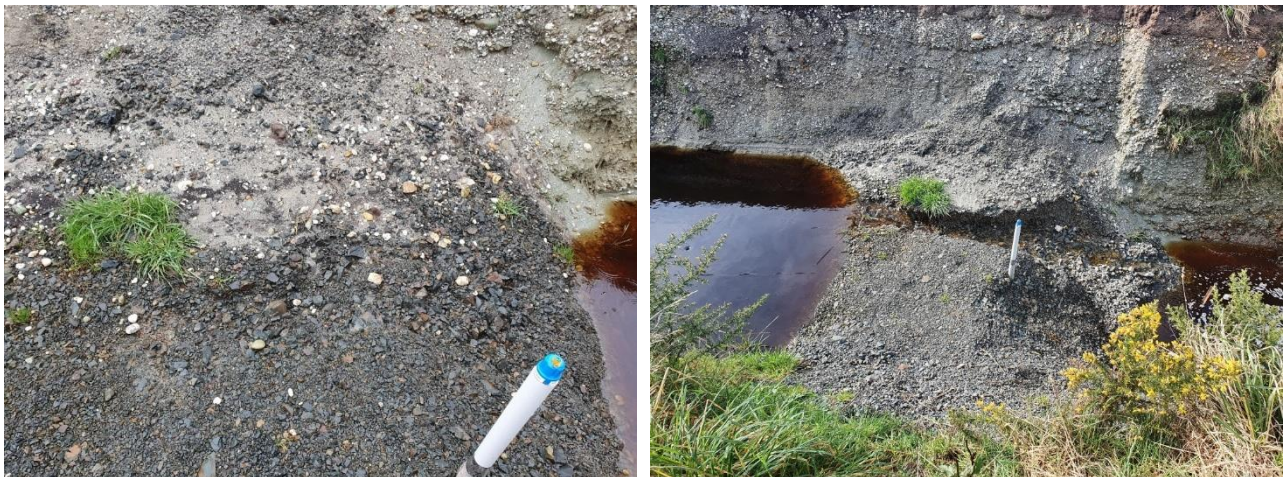
*Figure 12: Site 1 Gravel weir partial erosion (left) and subsequent initial failure (right), July 2021.*

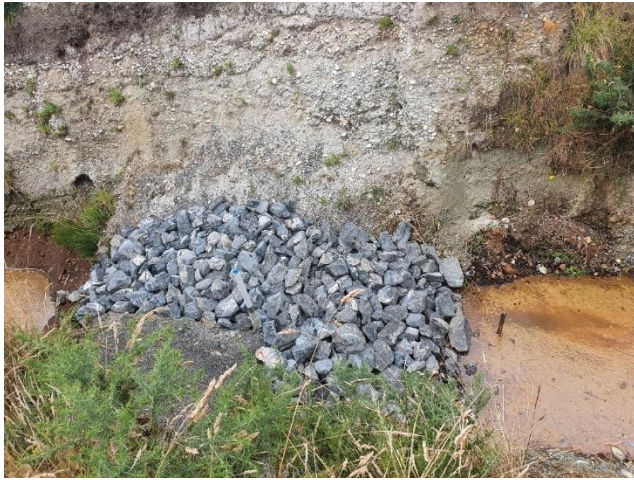
*Figure 13: Reinstatement of Site 1 utilising rock ballast.*

- Significant attenuation of peak discharge appeared to occur downstream of the gravel weir at Site 1. This may be due to the porous nature of the rock utilised to reinstate this structure after the initial failure. Discharge through the rock ballast is likely to enable partial dissipation of storage prior to overtopping of the weir.

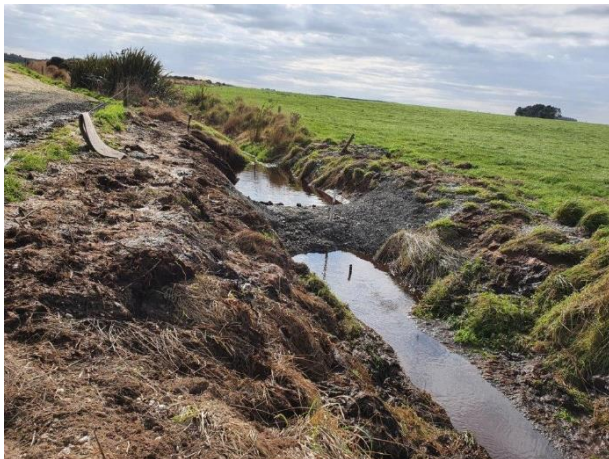
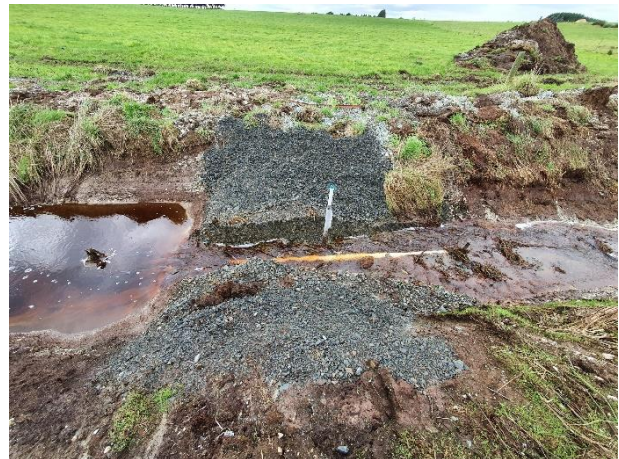
*Figure 14: Site 3 initial installation in May 2021 (left) and after initial failure in July 2021 (right).*

Similar structural integrity issues during high flow events were experienced with the gravel weir constructed at Site 3. These issues were associated with the greater fines content of the AP65 gravel utilised at this site (compared to Site 1), as well as the relatively high discharge at this site (due to

the larger contributing catchment area compared to the remaining PRC trial sites). After initial reinstatement utilising rock ballast, the structure failed again during the early September 2021 rainfall event. Ultimately the design of Site 3 was modified to incorporate a larger (150 mm) culvert pipe, as well as 3 additional 150mm culvert pipes located higher in the weir structure to accommodate higher flows. Due to initial failure of monitoring equipment, difficulties maintaining structural integrity of the site and the appreciably larger (and therefore not directly comparable with remaining sites) catchment area, monitoring at Site 3 was discontinued early in the trial period.

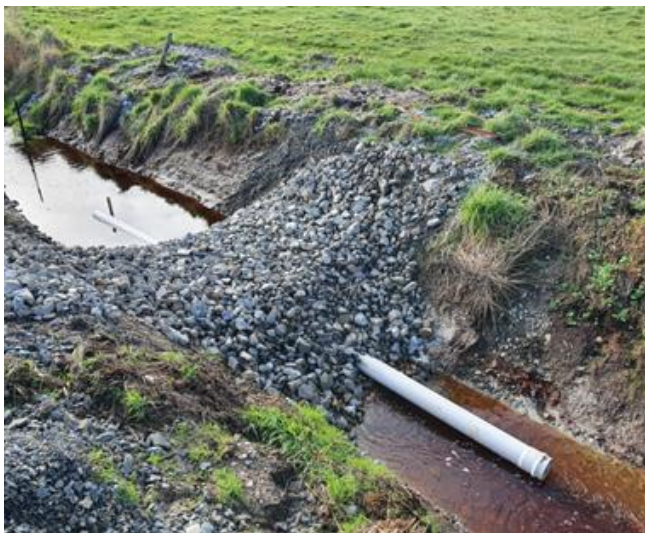
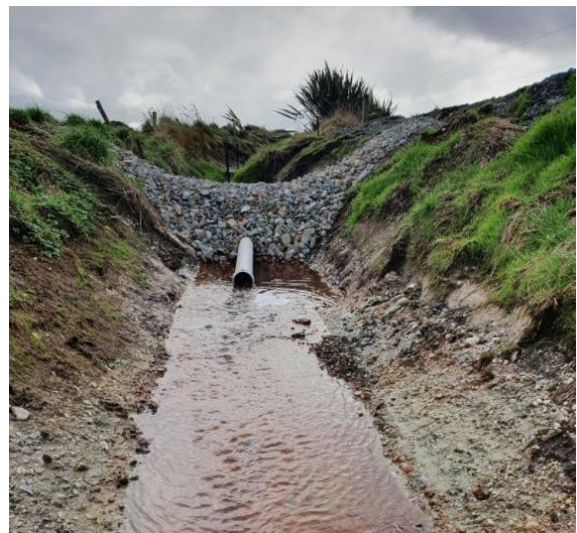
*Figure 15: Site 3 after instatement utilising rock ballast (22 July 2021).*

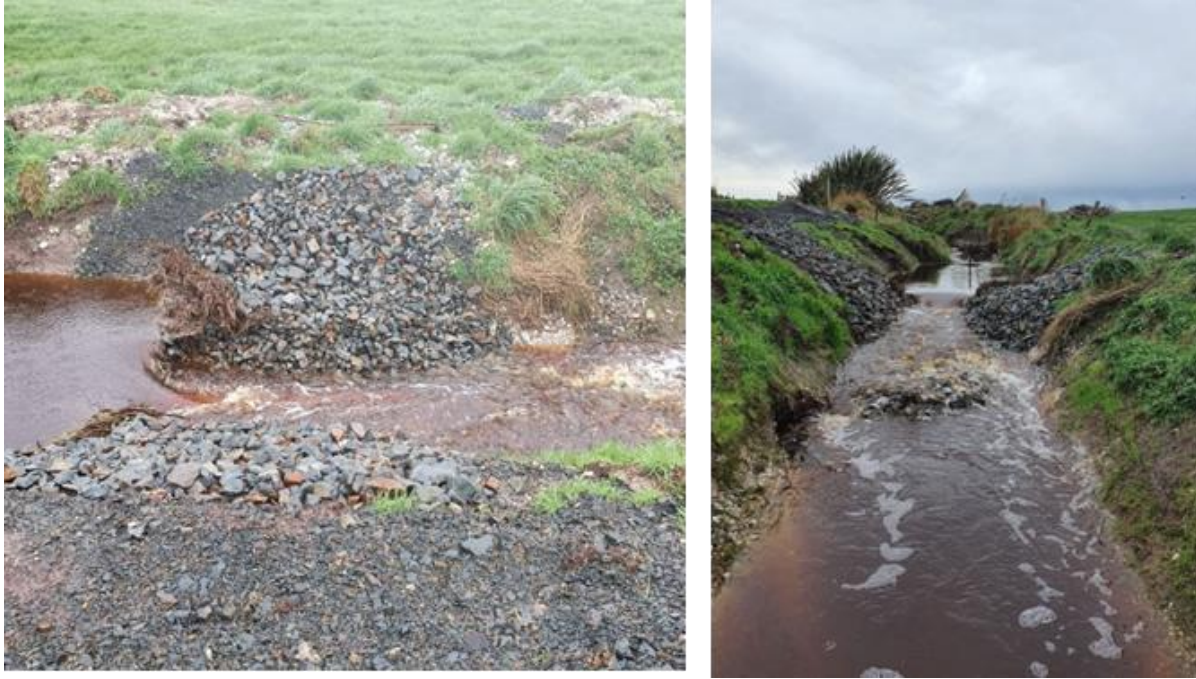
*Figure 16: Site 3 after second failure (10 September 2021).*

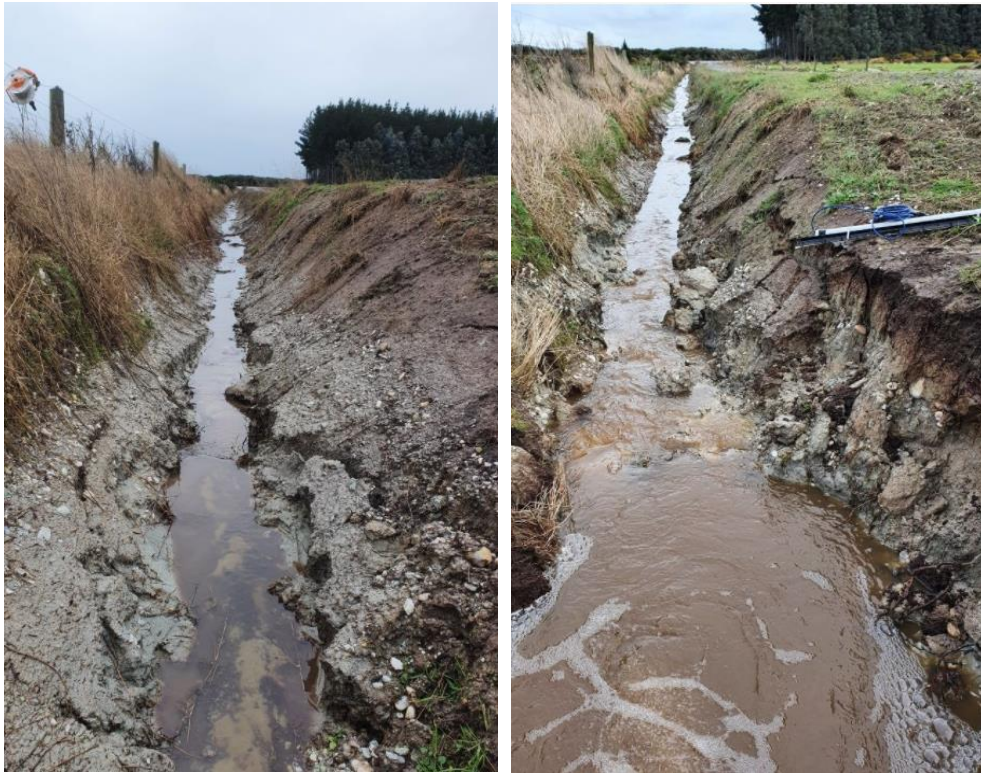
*Figure 17: Bed erosion and bank instability at the initial control site.*

The control site was established in a small catchment towards the southern end of the Foveaux Investments property. However, as illustrated on Figure 17 below, concerns were raised regarding the representativeness of the control site location due to extensive erosion of the stream banks and bed following drain cleaning undertaken during winter 2021. In addition, the initial control site was located on a drain which was observed to be downstream of a small wetland area identified as potentially influencing discharge, particularly during the winter months and/or following heavy rainfall.

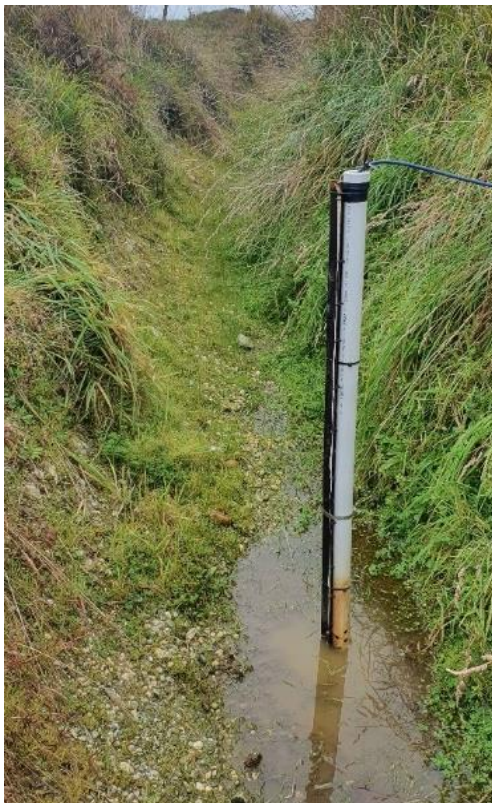
*Figure 18: Channel section at the final control site.*

To overcome these issues the site was shifted to a more stable stream location where monitoring recommenced in mid-December 2021. Figure 18 shows a photograph of the final control site.

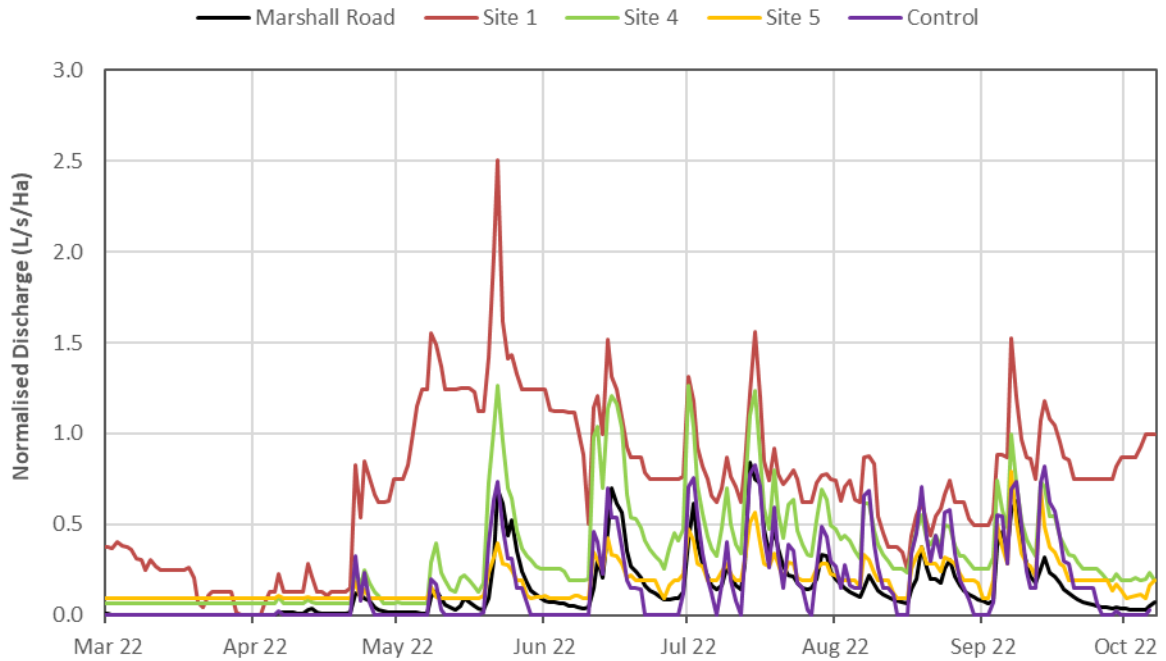
Figure 22: Naturalised discharge calculated for the PRC trial sites compared to Waituna Creek at Marshall Road, May 2021 to September 2022.

Naturalising of flows to the catchment areas upstream of the individual PRC sites would typically provide a relative measure of the effect of the individual structures in terms of modifying the natural stream hydrograph. However, due to difficulties reliably delineating catchment areas, specific discharge varies appreciably between the individual catchment area. As illustrated on Figure 22, while normalised discharge at Site 4 and the control site is similar to that calculated for the wider Waituna Creek catchment, the calculated discharge for Site 1 and Site 4 differ appreciably. These observations indicate that catchment areas for these sites listed in Section 3 above under-estimate actual catchment areas.

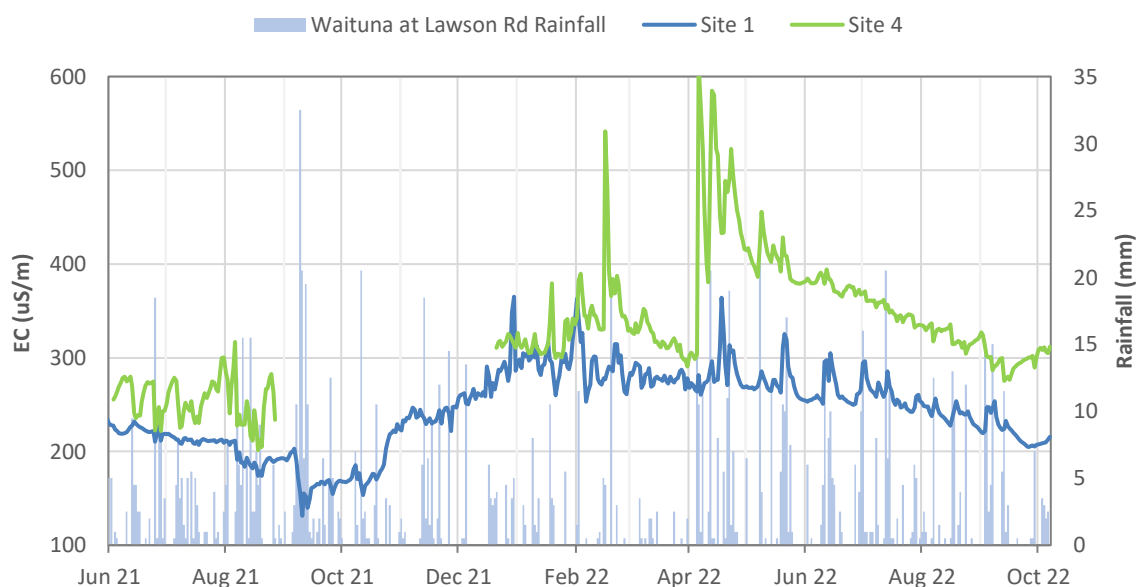
Figure 28. Electrical Conductivity measured at Site 1 and Site 4, June 2021 to September 2022.

Data from Site 4 exhibits a somewhat different temporal pattern to Site 1 with a significant spike in EC observed in early April 2022 followed by an ongoing decline through to October 2022.

The observed variations in EC are inferred to reflect the greater contribution of lower conductivity surface runoff to flows during the winter months with a larger contribution from higher EC soil waters and shallow groundwater during the 2022 summer and autumn. The large spike in EC observed at Site 4 may reflect mobilisation of dissolved contaminants accumulated in the soil zone over the relatively dry spring/summer period via the tile drainage network (which makes a significant contribution to flow at Site 4 (Dairy Green, 2022)).
